REPORT NO. NADC-78220-60

**THE DEVELOPMENT OF AMLGUARD, A CLEAR, WATER  
DISPLACING, CORROSION PREVENTIVE COMPOUND**

Gabriel J. Pilla  
Aircraft and Crew Systems Technology Directorate  
NAVAL AIR DEVELOPMENT CENTER  
Warminster, Pennsylvania 18974

11 May 1979

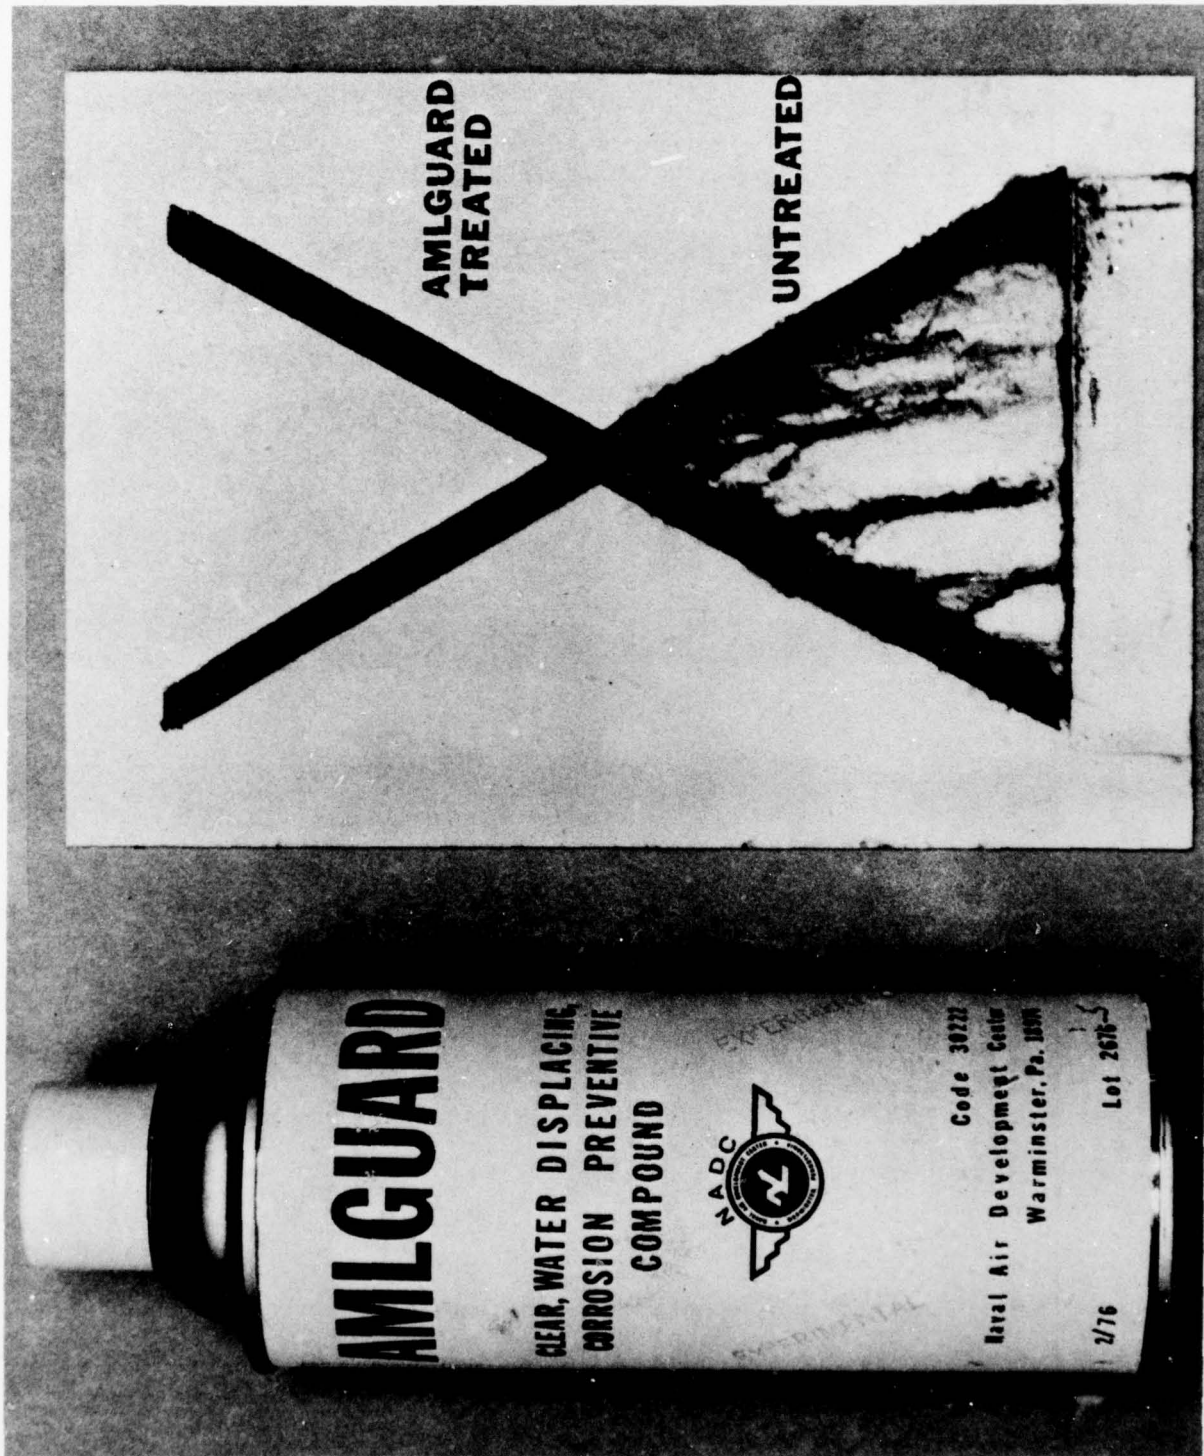
FIGURE 1. PARTIALLY PROTECTED 1010 STEEL PANEL EXPOSED TO 5% SALT SPRAY ENVIRONMENT FOR SEVEN DAYS

The use of silicone alkyd resin and silicone resin blended with small percentages of petroleum sulfonate and organic phosphate offer suitable corrosion protection without adversely affecting the required film properties of the newly developed compound, "AMLGUARD." (See Figure 1.)

1010 steel panels measuring 3" x 6" (76 mm x 152 mm) were painted and air dried for seven days. The panels were scribed with an X on their long axis down to the substrate metal. One half of the panel was treated with the corrosion preventive compound and air dried overnight before being exposed in the five percent salt cabinet. To illustrate the effectiveness of the test and the protection of the AMLGUARD see Figure 1.

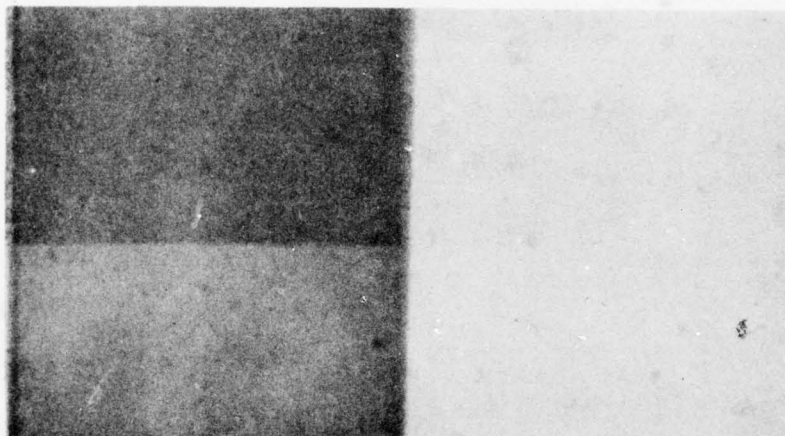
RIGHT SIDE OF EACH PANEL TREATED WITH MATERIAL IDENTIFIED ABOVE IT, LEFT SIDE UNTREATED

FIGURE 2. LIGHT/DARK GRAY PAINTED PANELS TREATED WITH AIRCRAFT CORROSION PREVENTIVE COMPOUNDS

Two criteria of the new compound requested by fleet personnel were clarity and dry film properties. The clarity of AMLGUARD relative to other military corrosion preventive compounds, MIL-C-81309 and MIL-C-16173 Grade 4, is illustrated by Figure 2. Evaluation sheets returned by fleet personnel requesting a tint or dye be added to the compound for application discernibility, attests to the compound's effective clarity. The dryness of the material is exhibited by its inability to be removed by rubbing or wiping after it is dry.

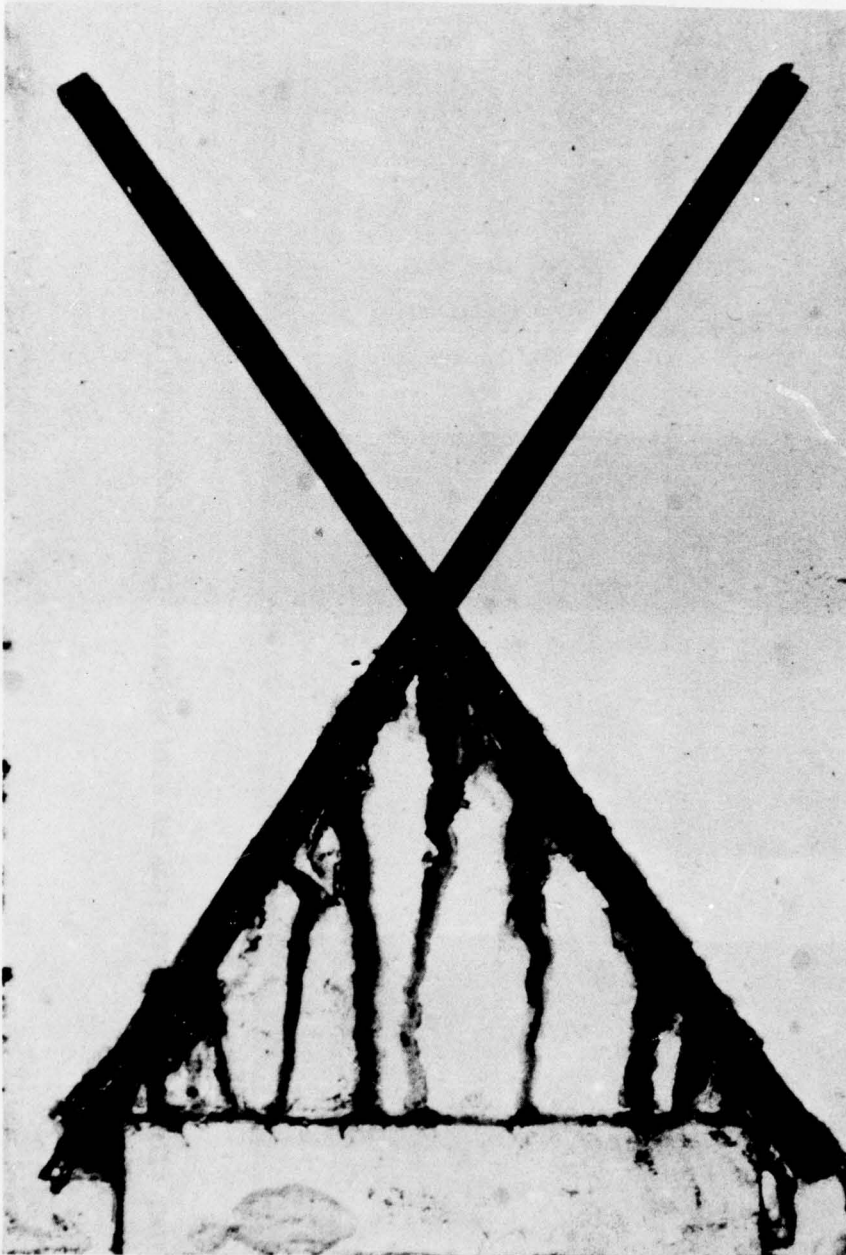
FIGURE 3. PARTIALLY PROTECTED 1010 STEEL PANEL EXPOSED TO  
5% SALT SPRAY ENVIRONMENT FOR SEVEN DAYS

The composition of AMLGUARD consists of a combination of resins, solvents, a thickening agent, a coupling agent and corrosion inhibitors. The major constituents in the formulation are the silicone alkyd resin and the silicone resins which were selected for their resistance to weathering, corrosion protection and heat stability, those service and performance conditions common to naval aircraft. Basically, the combined resins in the formulation provide a physical barrier from corrosive shipboard stack gases and sea spray. The solvents present in the compound have several functions, they promote water displacement, assist leveling of the compound, aid drying time, solubilize the thickening agent and facilitate compatibility between constituents. The inhibitors provide corrosion protection for the metal substrate. The thickening agent is added to give body to the compound to prevent run off and to achieve a one mil (0.001 in.) (0.025 MM) film thickness with two spray applications. The compound's drying time was controlled by selection of solvents based on their evaporation rate without destroying the water displacement properties and compatibility with formulation constituents. The drying time was controlled to accomplish water displacement before a film could form over water droplets. The early version of the compound being virtually colorless by design made it almost impossible to differentiate where it had been applied on the aircraft surface without close observation. The fleet personnel evaluating the new compound indicated that some coloration would be desirable to distinguish where the AMLGUARD was applied and in what quantity. A blue dye was added to the compound for discernibility (Figure 3) on aircraft surfaces.

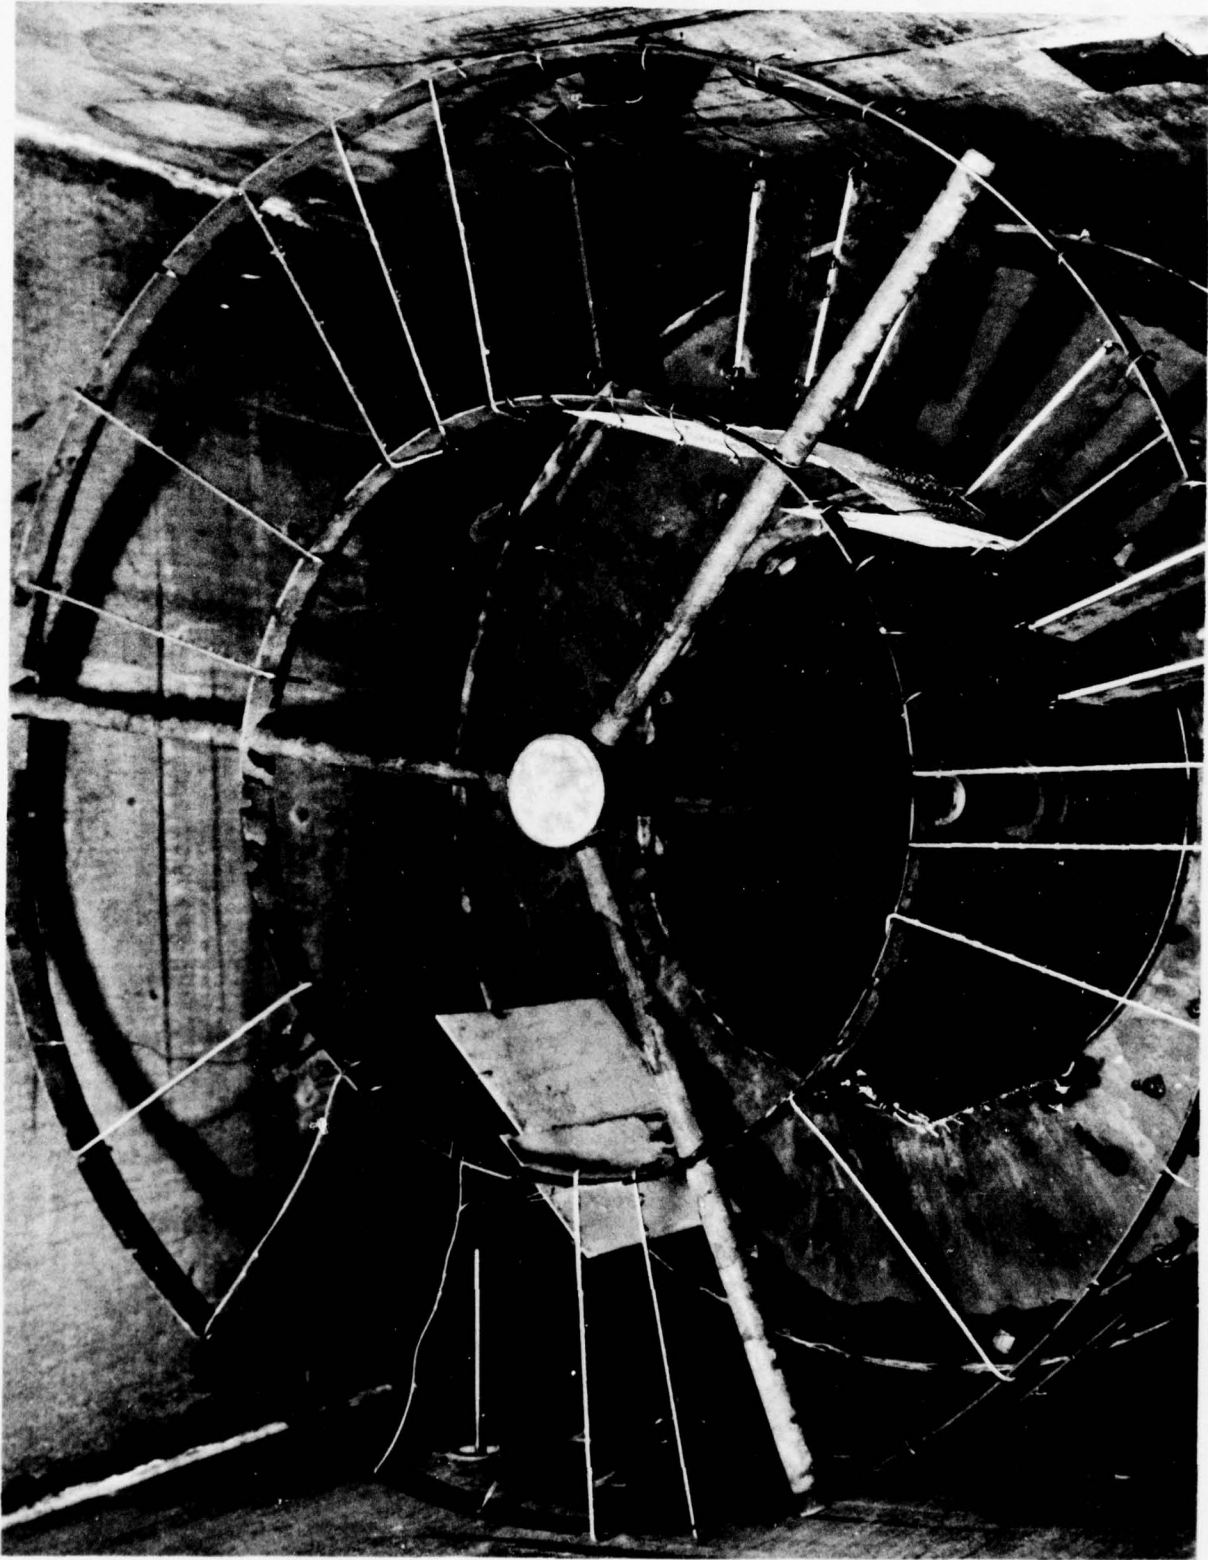
FIGURE 4. HUMIDITY CABINET 100% RELATIVE HUMIDITY @ 120°F

ASTM D1748-70 \* was used to determine the experimental compound's ability to protect 1010 steel when exposed to a sustained 100% humidity environment for prolonged periods. This simulates a climatic condition that some naval aircraft will experience during a deployment. The test utilizes a humidity chamber where a condensing condition at +120°F (49°C) is produced by air bubbling through diffuser stones which are submerged in water heated to +140°F (60°C) (Figure 4). A constant rotating specimen holder is used to suspend the test specimens in the humidity chamber to assure uniform moisture deposit on each test specimen.

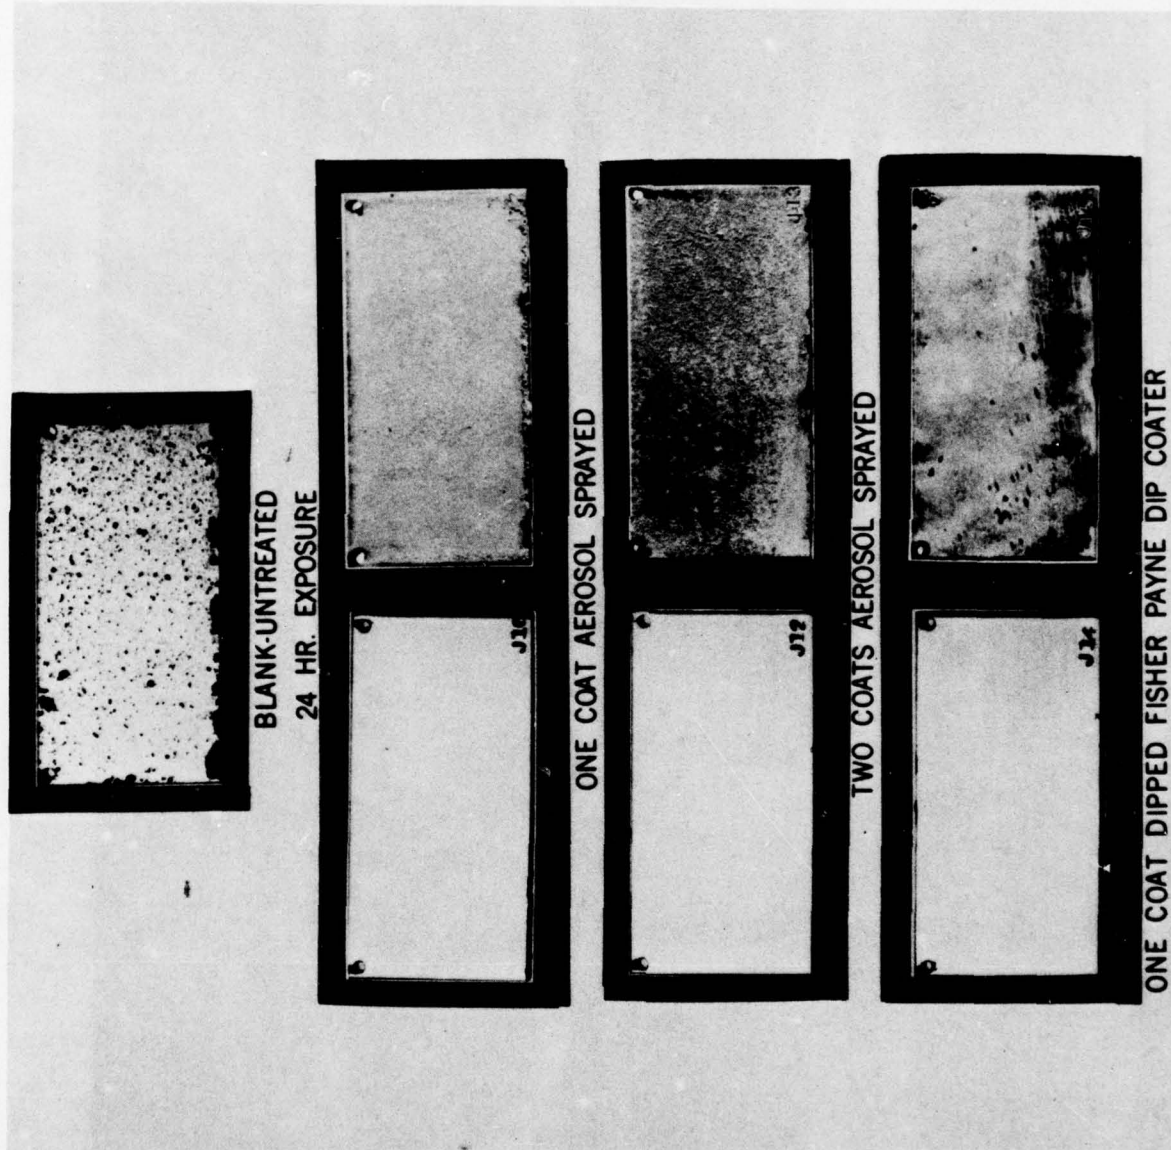
FIGURE 5. 1010 STEEL TREATED WITH "AMLGUARD," SUBJECTED TO 100% RELATIVE HUMIDITY @ 120°F FOR 65 DAYS. "AMLGUARD" REMOVED WITH MINERAL SPIRITS FROM PANELS ON LEFT SIDE TO SHOW PROTECTION AFFORDED.

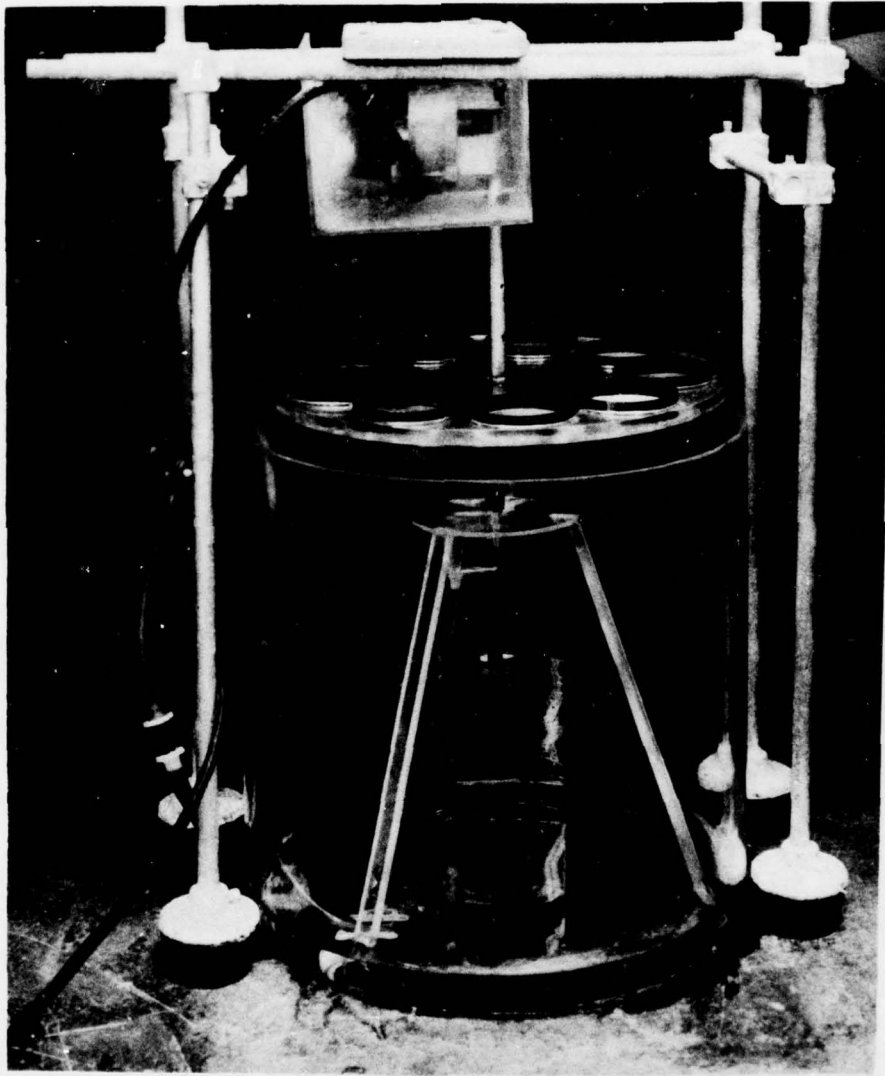
FIGURE 6. EQUIPMENT FOR SULFUROUS ACID/SYNTHETIC SEA SPRAY TEST

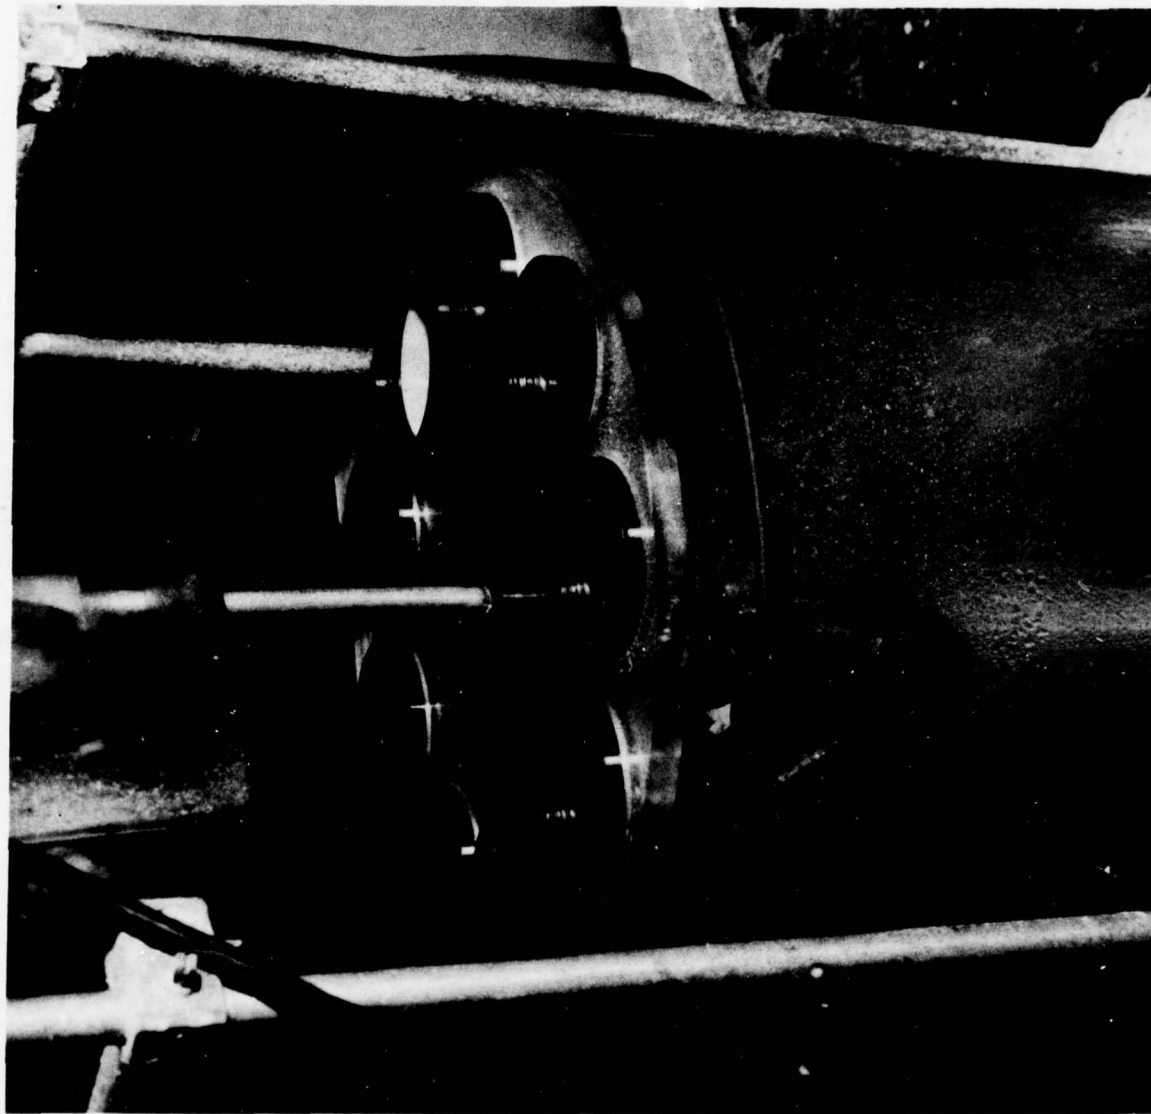
FIGURE 7. SULFUROUS ACID/SYNTHETIC SEA SPRAY TEST IN OPERATION

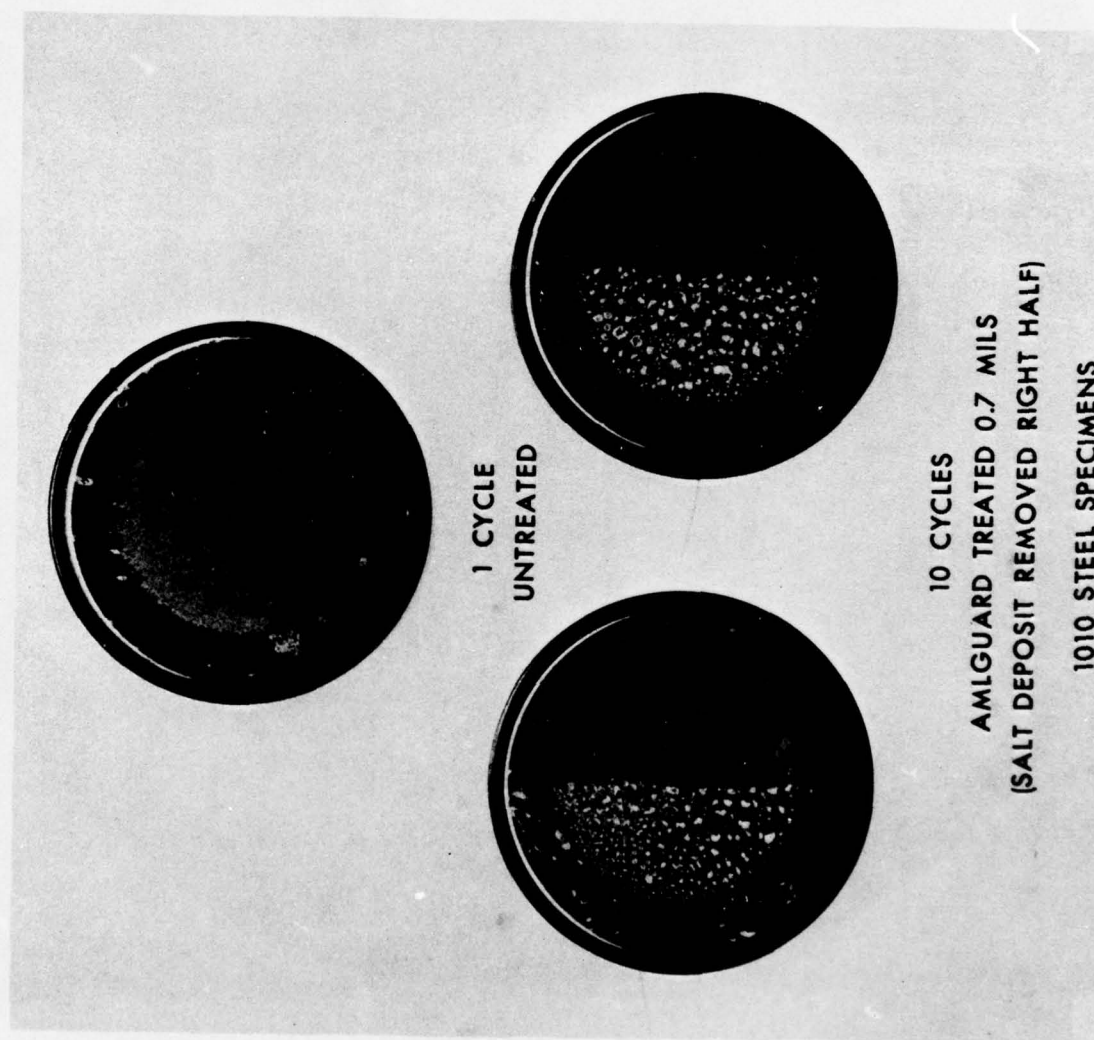
FIGURE 8. SIMULATED CARRIER DECK ENVIRONMENT  $H_2SO_3$  /SEA SPRAY TEST

The significance of this test was to determine the corrosion protection capability of the experimental compound under a simulated aircraft carrier deck environment. This test was used for the development of the forerunner Corrosion Preventive Compound MIL-C-81309. Basically, the test is a cycling of sulfurous acid/synthetic sea water solution atomized for one hour by air pressure to produce a fog or mist (Figure 7) and air dried for three hours. Sulfurous acid is the acid produced when carrier stack gases containing sulfur dioxide (combustion products of bunker C fuel) combine with water vapor from the sea spray. Reagent grade sulfurous acid was added to the synthetic sea water in the percentage necessary to achieve corrosion equivalent to that obtained with the combustion products of bunker C fuel. Synthetic sea water used in the test simulates natural sea water. The synthetic sea water consists of chemical salts and their percentages approximating those existing in a composite of natural sea water. Details concerning the test procedure are explained in Naval Air Development Center report No. AML 2436 titled, "Development of Environment Wet Test Chamber for Simulating Carrier Deck and Other Corrosive Environment", dated 11 May 1966. Test specimens consisting of 1010 steel measuring 2-1/8 inches (54 mm) in diameter by 1/16 of an inch (1.5 mm) thick were used for this test. The test specimens were coated in the same manner used to prepare the humidity chamber test specimens, by either the Fisher Payne Dip Coater method and/or the spraying method, from either the aerosol package or the MIL-S-22805 aerosol spray kit. The test specimens, spray coated and air dried overnight, were subjected to the simulated carrier deck environment ( $H_2SO_3$ /Sea Spray Test). Comparatively, Figure 8 shows the specimens treated with AMLGUARD and exposed for 10 cycles were adequately protected from the corrosive environment, whereas, the untreated specimen when exposed for one cycle, severely corroded. Figure 9 depicts a typical salt deposit after five cycles.

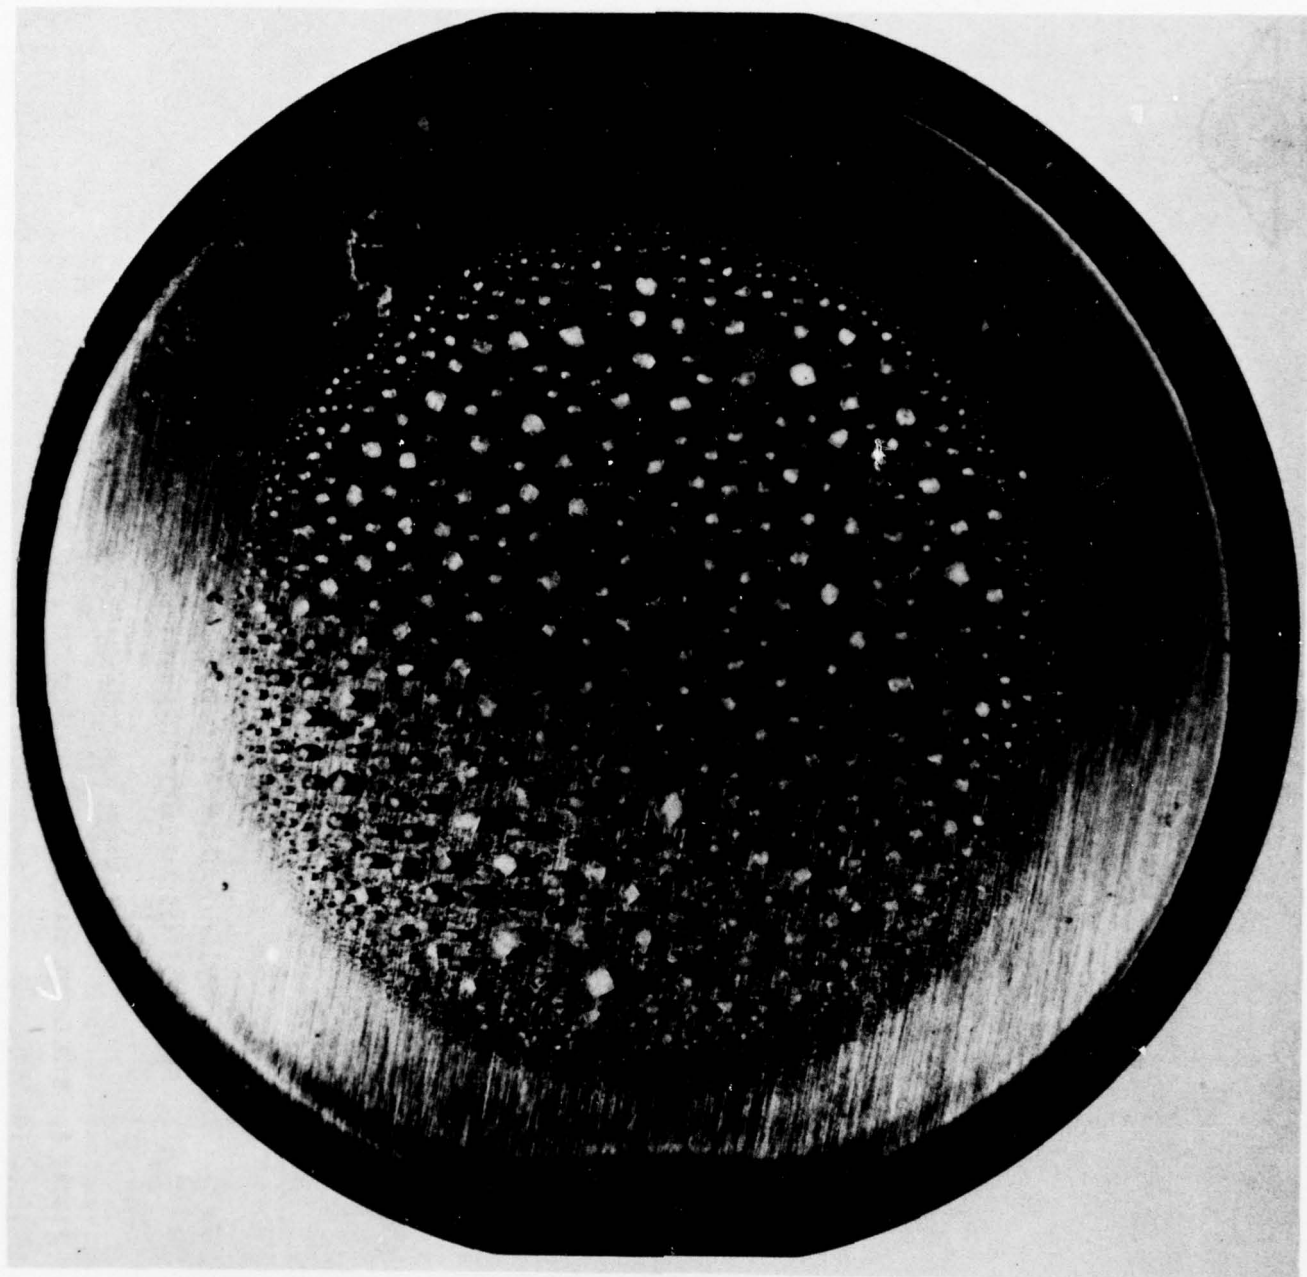
**SPECIMEN TREATED WITH AMLGUARD DEPICTING TYPICAL  
SALT DEPOSITS AFTER 5 TEST CYCLES**

FIGURE 9. SULFUROUS ACID SYNTHETIC SEA WATER SPRAY TEST SPECIMEN

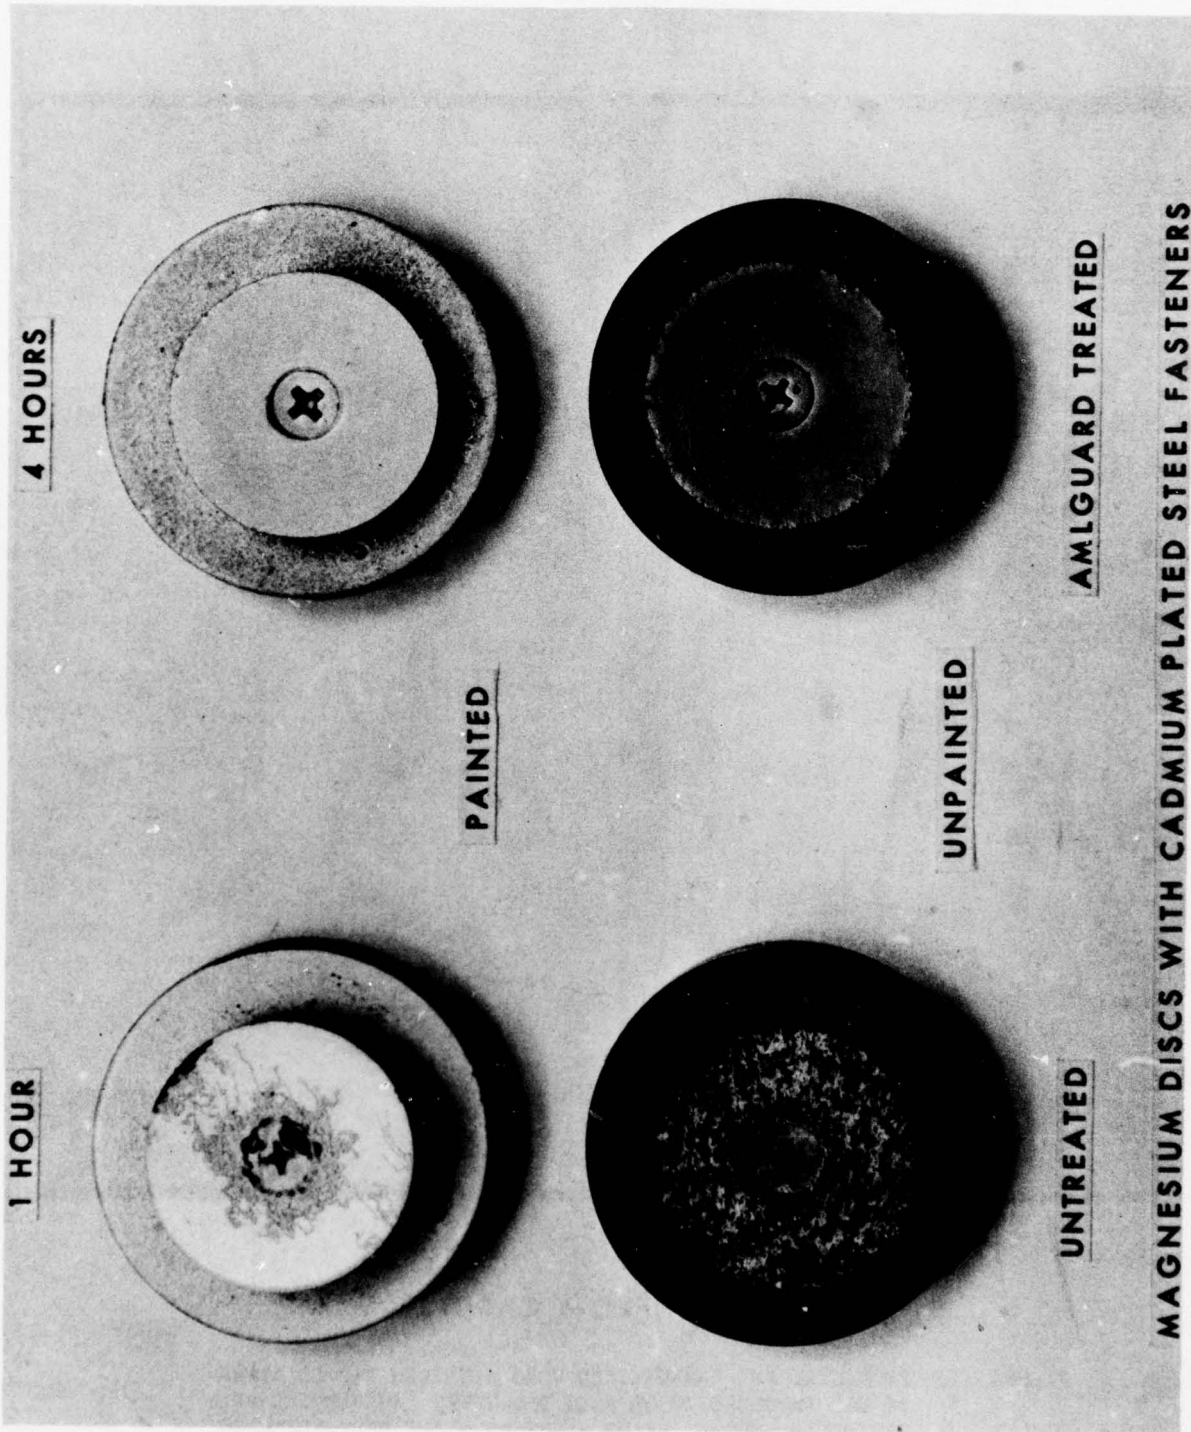
FIGURE 10. ACCELERATED LABORATORY TEST SIMULATED CARRIER DECK ENVIRONMENT

A dissimilar metal corrosion test was conducted to demonstrate the effectiveness of AMLGUARD on a magnesium-cadmium plated steel coupling on both painted and unpainted specimens. The test consisted of a specification QQ-M-44 magnesium disc two inches (51 mm) in diameter by 1/4" inch (6.3 mm) thick, with a countersunk hole in the center to accommodate a cadmium-plated steel aircraft fastener. A pair of disc assemblies were painted and another pair were left bare. A painted disc assembly and a bare disc assembly were treated with AMLGUARD and air dried overnight. The four discs were subjected to the  $SO_2$ /salt spray test mentioned above. The untreated specimens both painted and unpainted were exposed for one hour to the corrosive environment and showed severe corrosion or attack. The AMLGUARD treated specimens both painted and unpainted were exposed for four hours to the same environment and displayed no evidence of attack, see Figure 10.

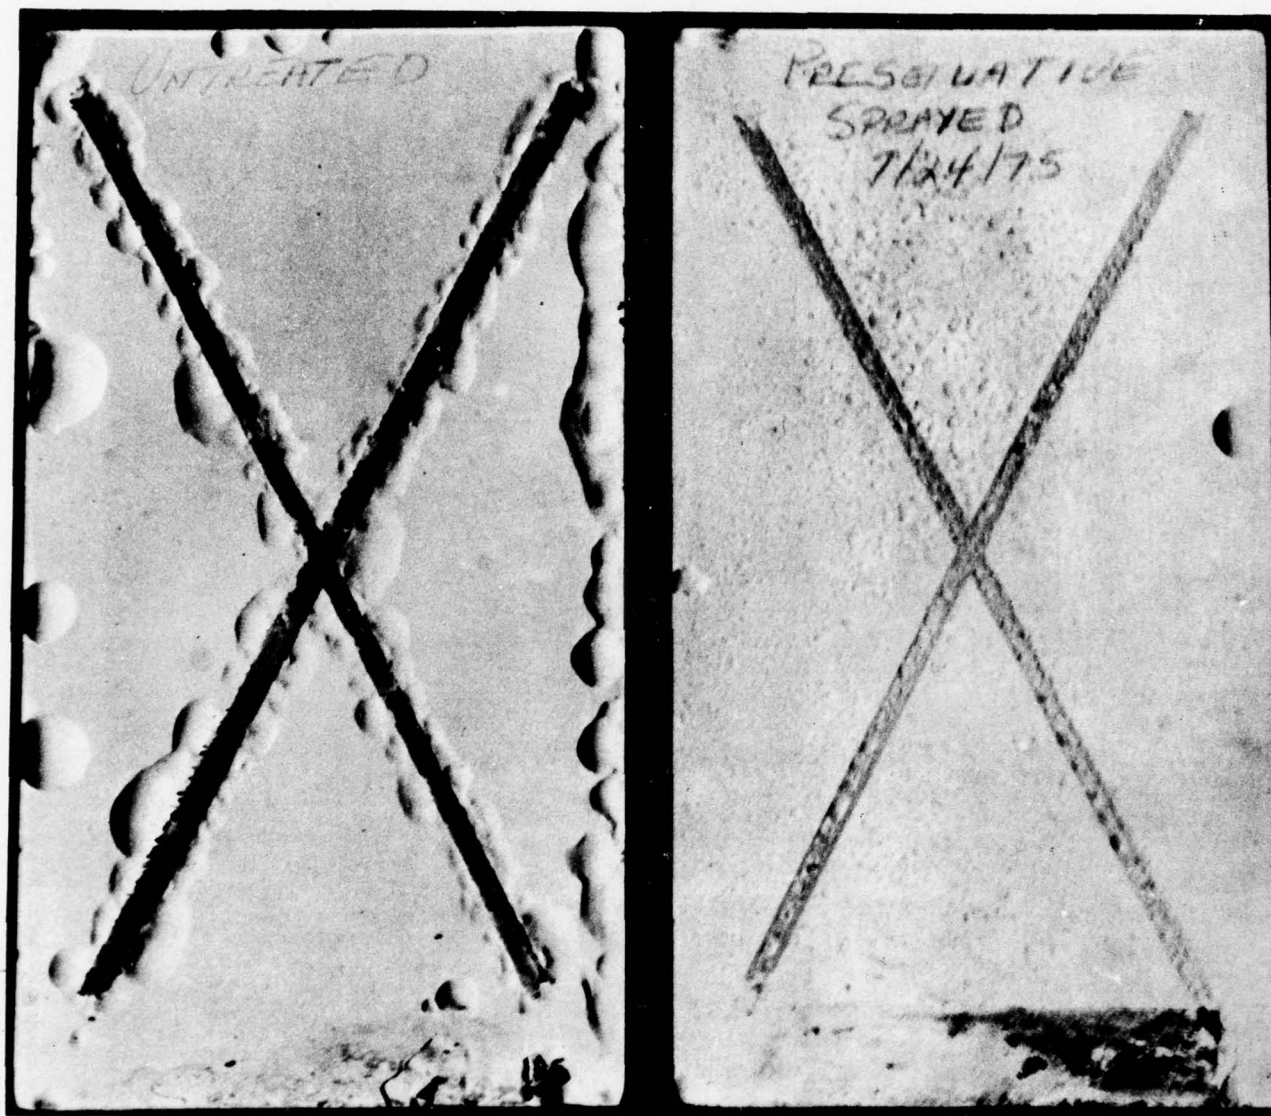
FIGURE 11. PROTECTED AND UNPROTECTED 7075 ALUMINUM PANELS AFTER 90 DAY EXPOSURE TO 5% SALT/SO<sub>2</sub> SPRAY (AS REMOVED FROM CABINET). NOTE: PAINT BLISTERS ALONG SCRIBED MARKS ON UNPROTECTED (LEFT) PANEL.

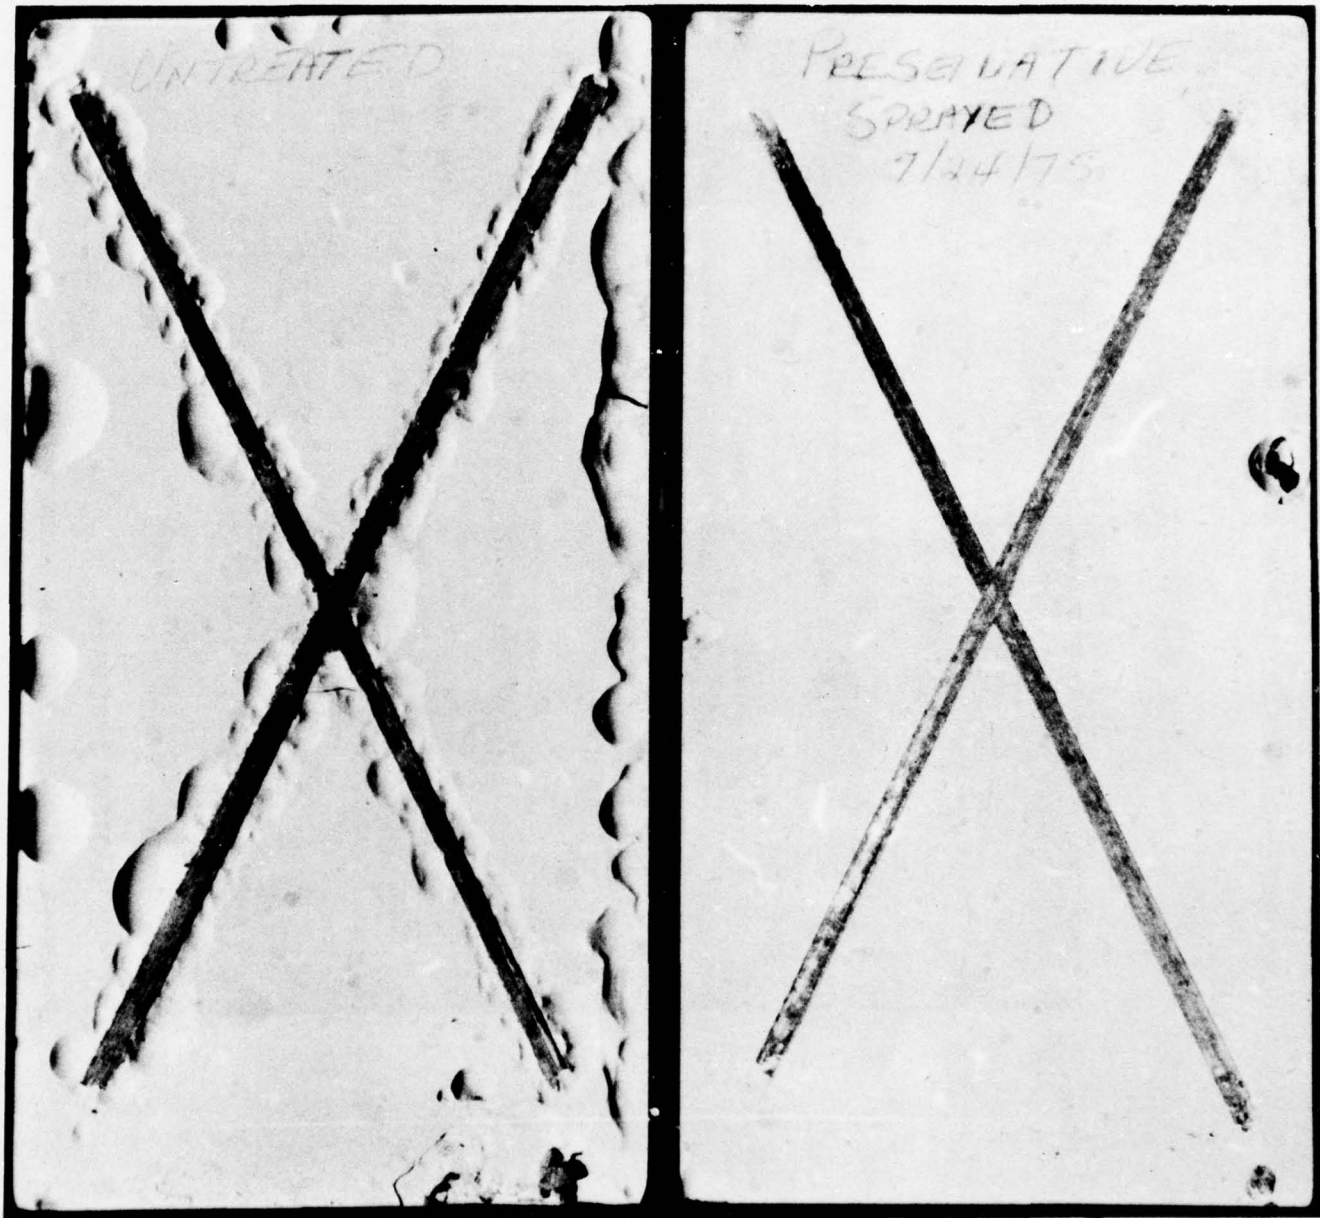
FIGURE 12. PANELS PICTURED IN FIGURE 11 AFTER SOLVENT WIPING. PROTECTED AND UNPROTECTED 7075 ALUMINUM PANELS AFTER 90 DAY EXPOSURE TO 5% SALT/SO<sub>2</sub> SPRAY (AS REMOVED FROM CABINET) AFTER SOLVENT WIPE.

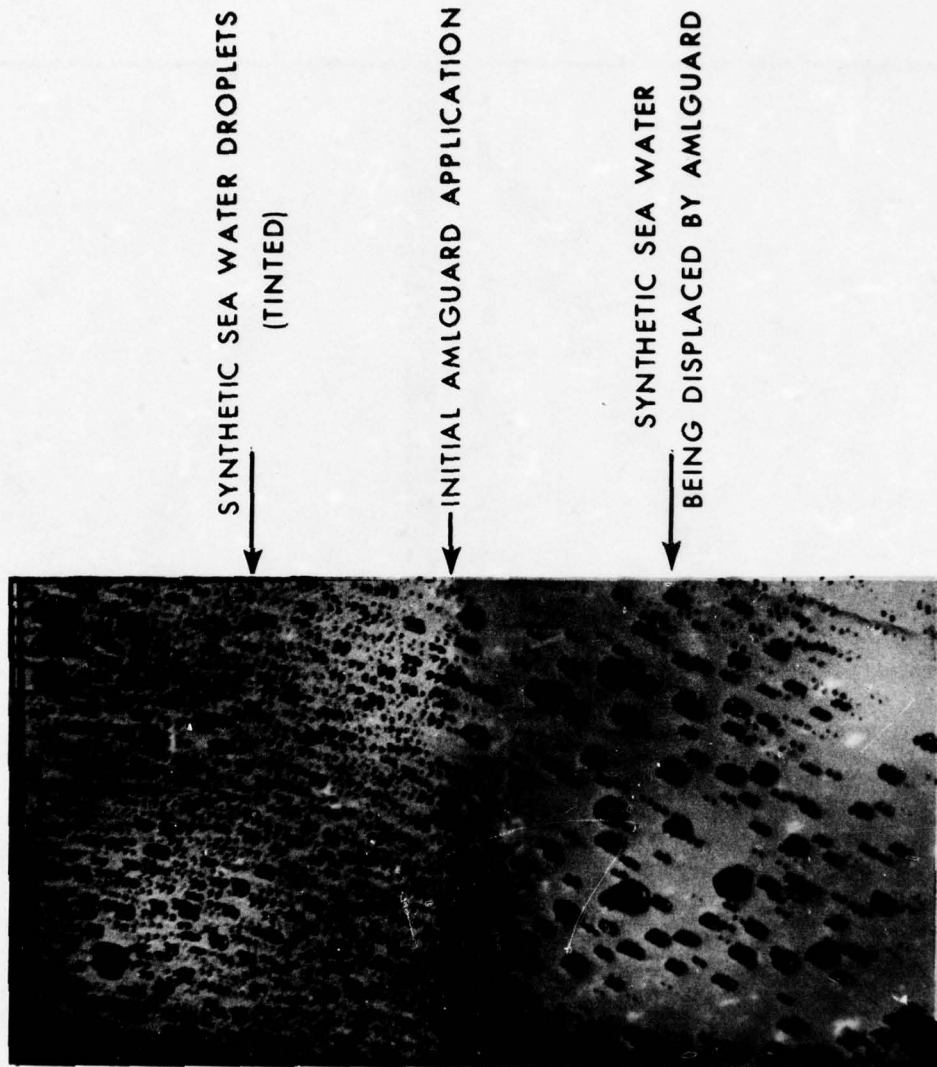
FIGURE 13. SYNTHETIC SEA WATER DISPLACEMENT TEST

The following test was conducted simulating a corrodible aircraft surface laden with sea spray in order to evaluate the synthetic sea water displacement and corrosion protection capabilities of the experimental formulas. Steel test panels, 2" X 4" (50 mm X 101 mm) conforming to FS 1010 of MIL-S-7952, were used for this test. The test panel was placed so that one 2-inch (50 mm) end was raised one inch (25 mm) above a horizontal surface. The entire panel was sprayed with synthetic sea water consisting of: 50 grams of sodium chloride (NaCl); 22 grams of magnesium chloride (MgCl<sub>2</sub>·6H<sub>2</sub>O); 3.2 grams of calcium chloride (CaCl<sub>2</sub>·2H<sub>2</sub>O) and 8.0 grams of sodium sulfate (Na<sub>2</sub>SO<sub>4</sub>) added to a litre of distilled water. Within one minute after spraying the sea water one milliliter of the test compound was poured along the upper two-inch (50 mm) edge of the panel and allowed to run slowly down the specimen so as to completely cover the test panel. To illustrate AMLGUARD's water displacing ability, the synthetic sea water was tinted red. In Figure 13 the mid portion of the panel had AMLGUARD applied to it. Even at the outset, it can be seen that AMLGUARD is displacing the sea water. After one minute from the initial application, a second milliliter of the test compound was poured and allowed to run down the panel in the same manner. After waiting an additional minute, the panel was hung in a vertical position for one minute. A photo was taken at this time and as depicted by Figure 14, almost all of the sea

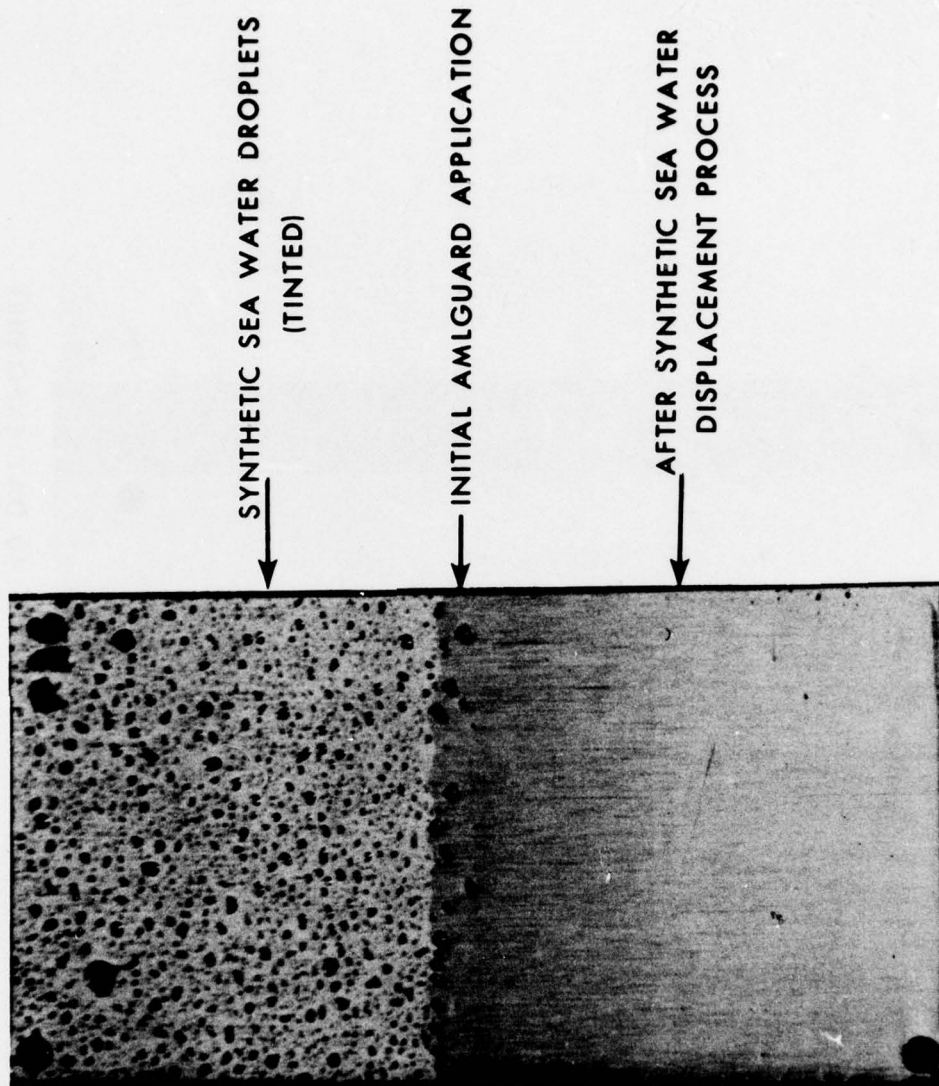
FIGURE 14. SYNTHETIC SEA WATER DISPLACEMENT TEST

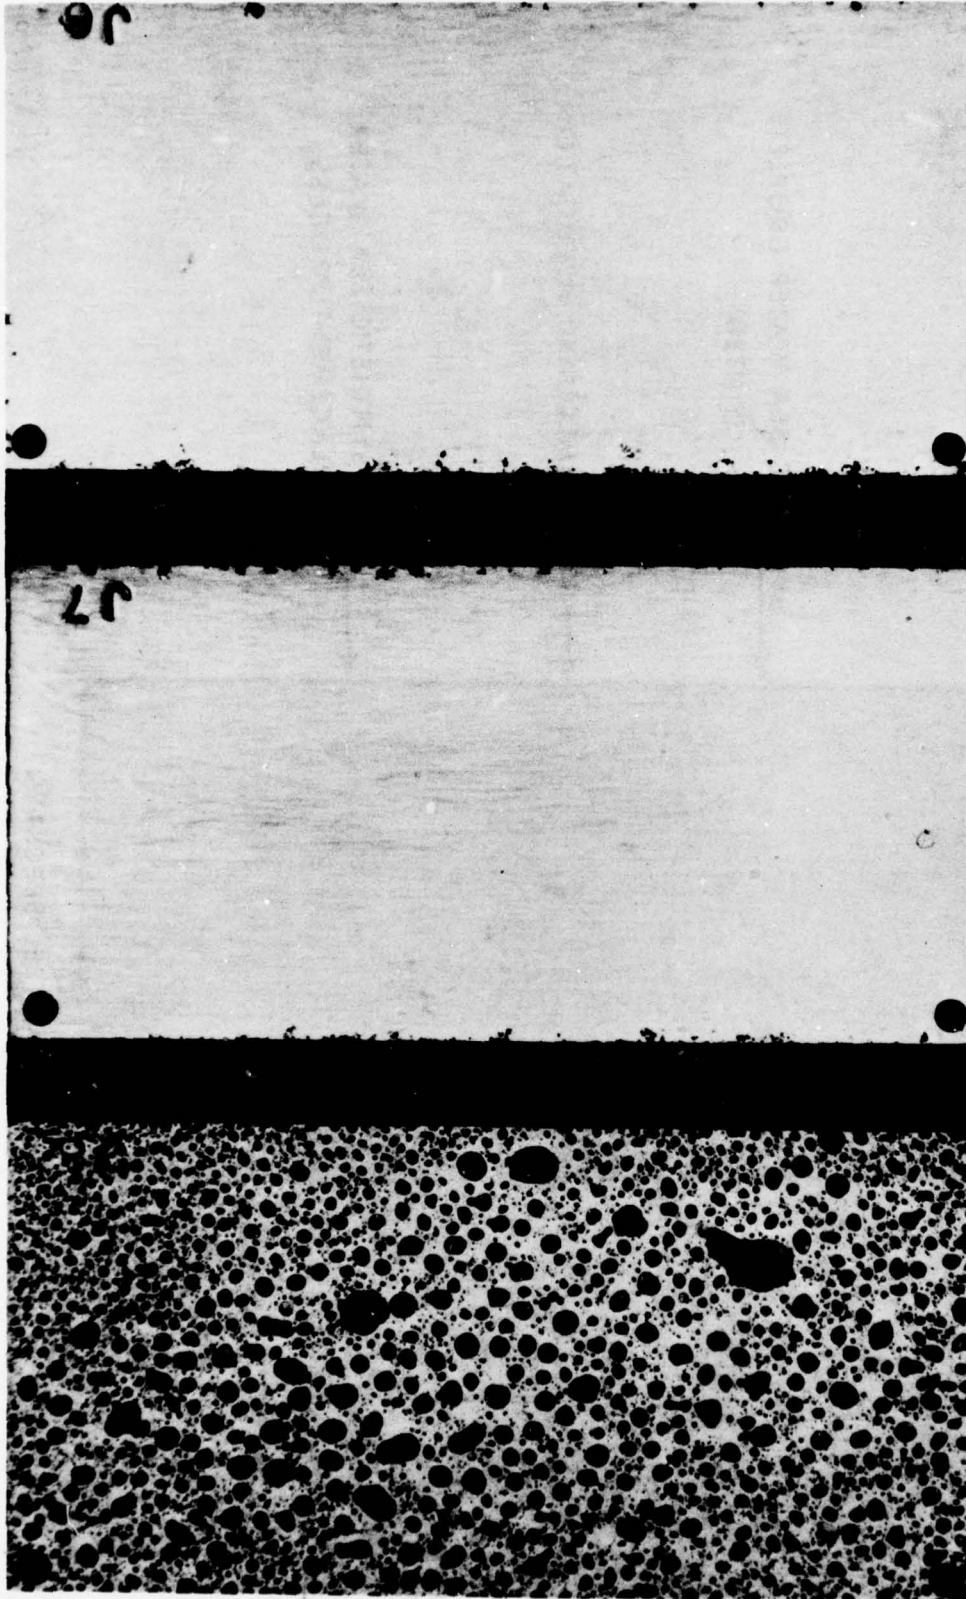
SEA WATER EFFECTIVELY DISPLACED  
AND PROTECTED BY AMLGUARD

FIGURE 15. SYNTHETIC SEA WATER DISPLACEMENT PANELS AFTER EXPOSURE TO 100% HUMIDITY

water is displaced. The specimen was then placed flat (test side up) above distilled water @ 72°F in a closed desiccator (100% static humidity). After four hours, the panel(s) were removed and cleaned with mineral spirits, and then evaluated for presence of visible corrosion. The effectiveness of the test is best demonstrated by the corrosion on the blank or untreated specimen in four hours versus the sea water displacement and corrosion protection provided on specimens treated with AMLGUARD and exposed for 40 days. These effects are noted in Figure 15.
